**TOWN OF TUFTONBORO**  
**240 MIDDLE ROAD, TUFTONBORO, NH**  
**NEEDS ASSESSMENT AND FEASIBILITY STUDY- PROPOSED NEW POLICE DEPARTMENT**  
**MAY 2019**

In late 2018, the Town of Tuftonboro retained the services of Alba Architects and their engineering team to conduct existing conditions review, analysis, and assessment of the existing police department building located at 240 Middle Road, Tuftonboro, New Hampshire.

## 2.1 ARCHITECTURAL/SYSTEMS DESCRIPTION

APPENDIX I      **Existing Conditions Photographic Survey**

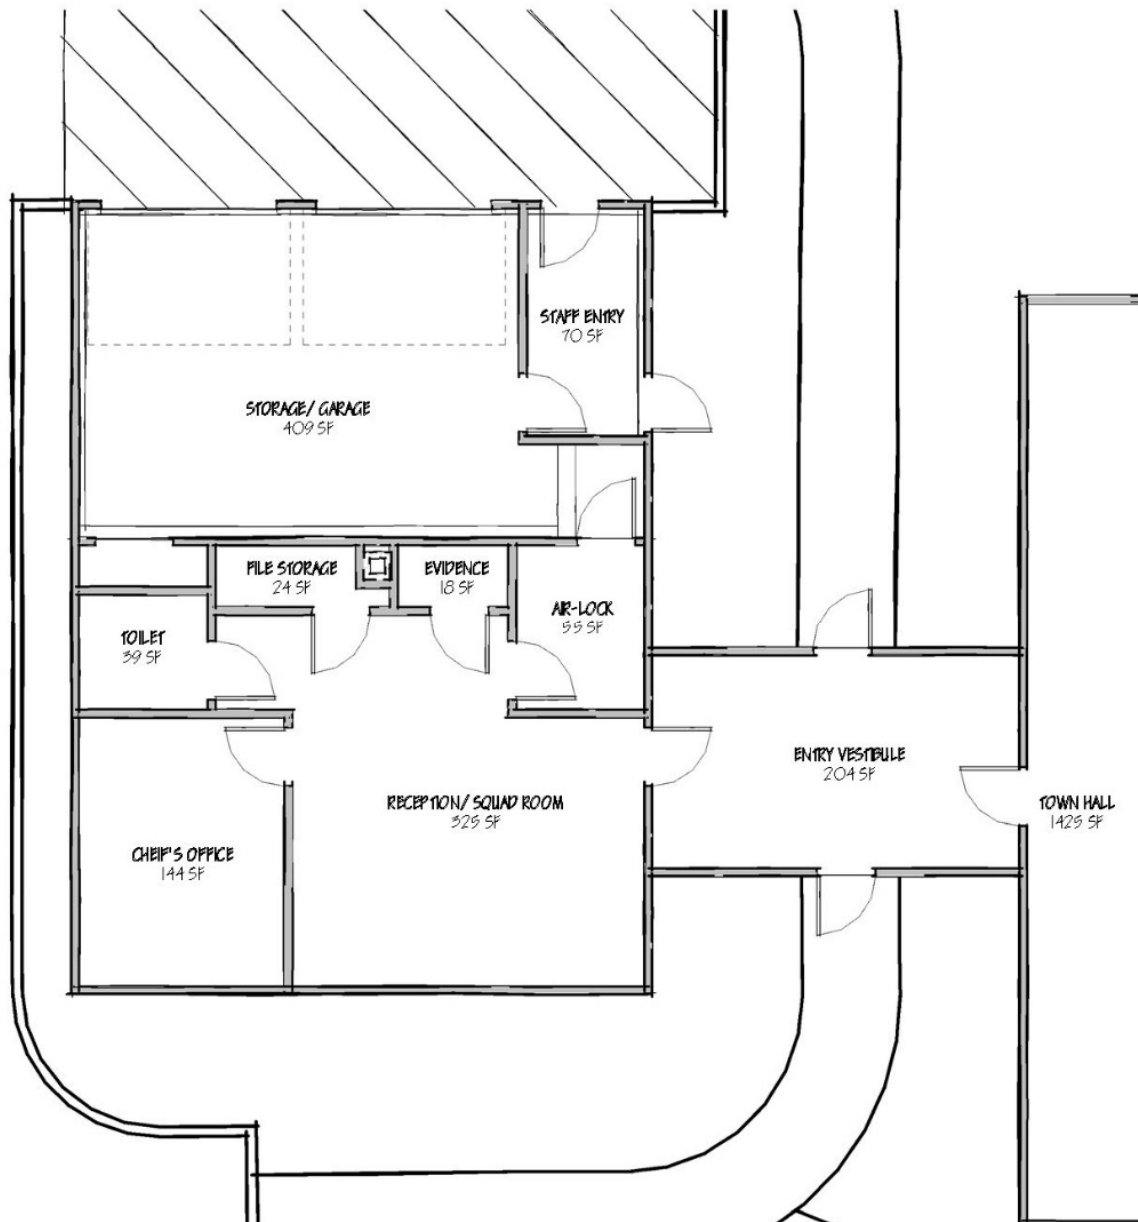
## 2.4 EXISTING CONDITION BUILDING PLAN

The existing building has a footprint of approximately 1,207 gross square feet. Within that footprint, the gross interior space (usable space) is approximately 917 square feet, including the 409 square feet of the garage space. See attached Existing Building Plans for detailed breakdown.

Note: Sketch floor plan based on casual field observations. These drawings are for spatial awareness only and do not fully represent all existing conditions.

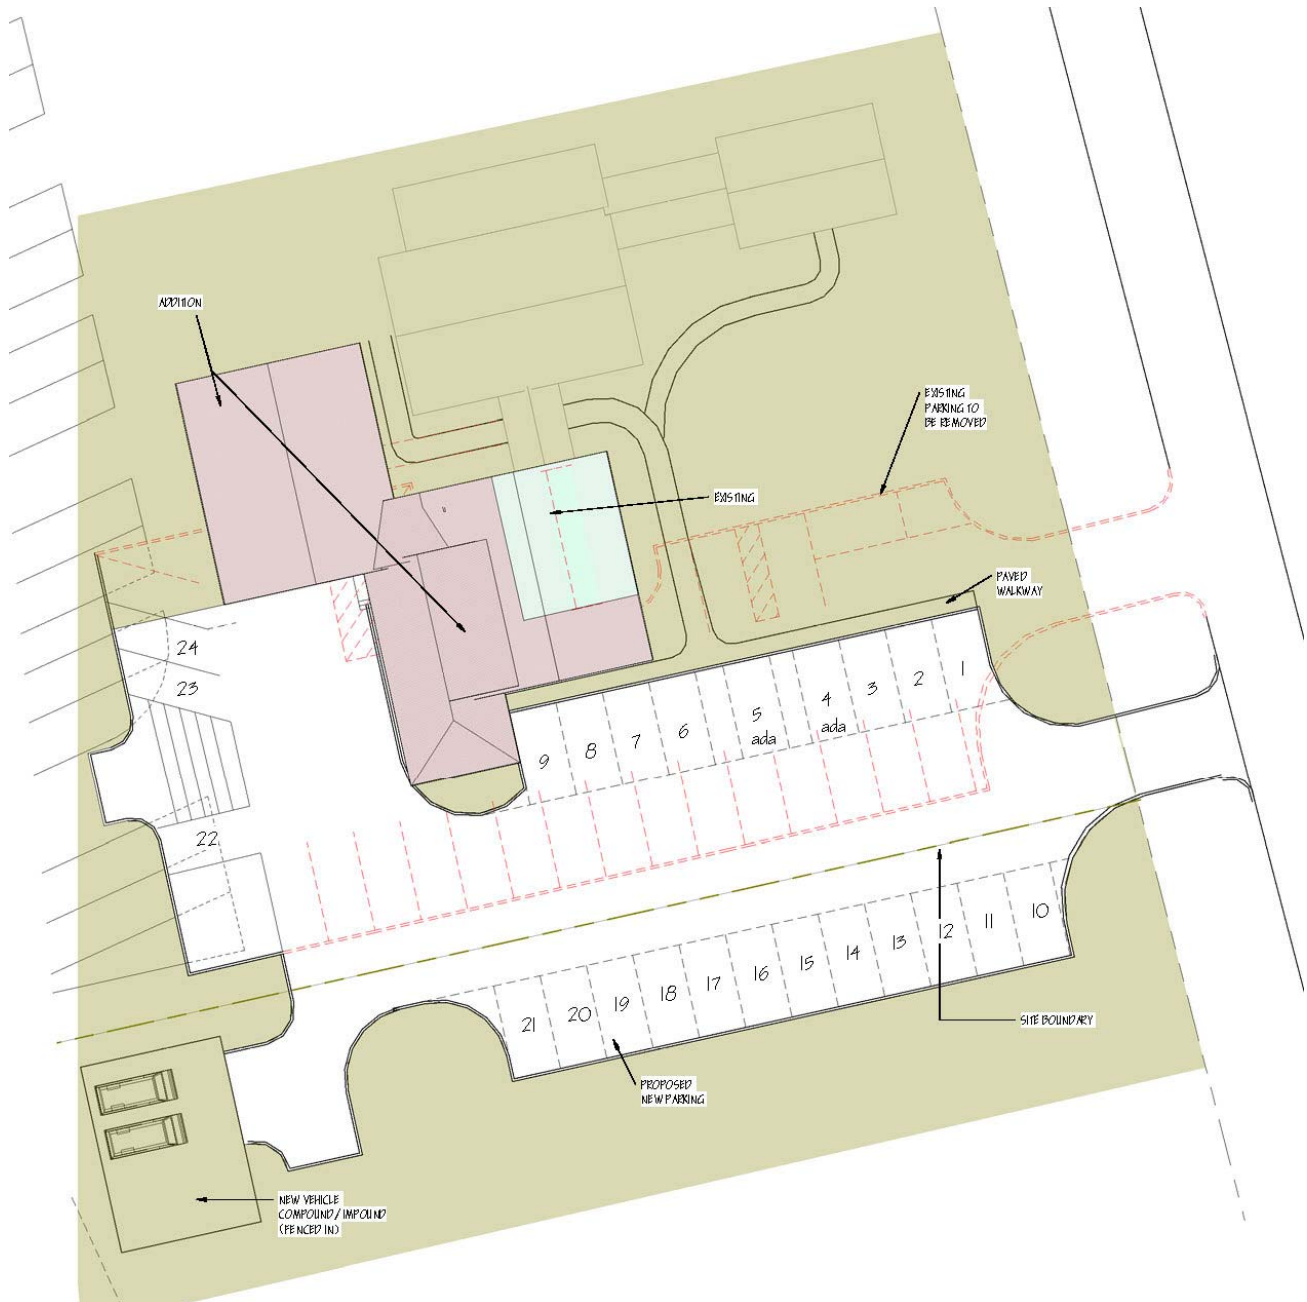
### 3.4 BASE PLAN- SITE DEVELOPMENT

Due to the inherent under-specification of the existing structure, it has been deemed impractical to retain any more than the full foundation basement and first floor structure of the existing facility. Therefore, the schematic design of the base plan is essentially the utilization of the existing first floor and basement with all new exterior walls, and additions toward the community gardens and cemetery as much as is deemed practical, on a combination of frost walls/crawl spaces and frost walls/slab on grade spaces. The overall new structure is then covered with a series of new trussed roof elements over the entire new layout. Site parking will require to be rearranged to suite new building layout, including expanding on to the community garden to form the lost and additional parking necessary to satisfy parking needs for both town hall and police station.

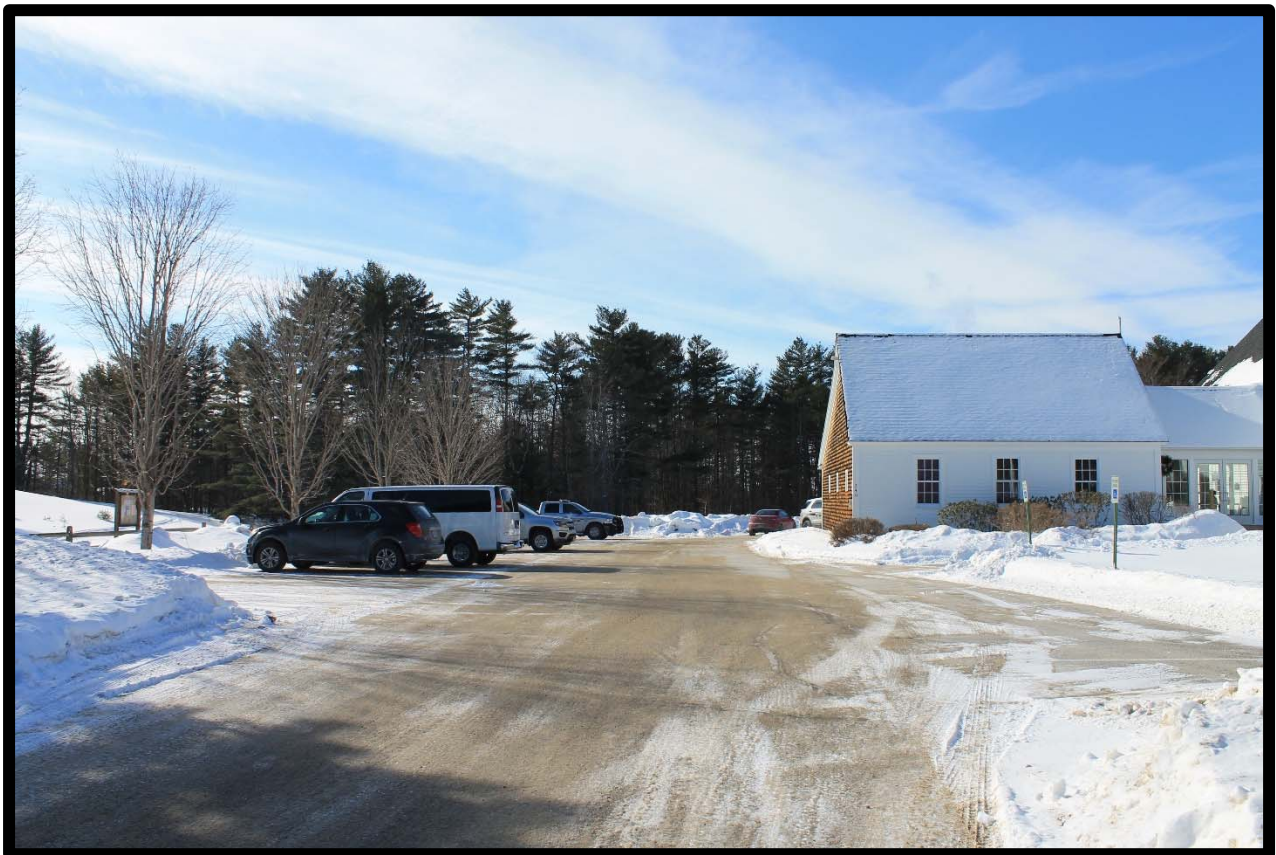
### 3.6 OPTION 1-EXISTING SITE

Approximate Size:	Town owned site, developing 41,000sf of 157,075sf.
Topography:	Flat area at street, sloping steeply to west of site
Existing Infrastructure:	All new infrastructure required, new well and septic included
In Current Use:	Previously developed site, presently cleared.
Proposed Building Footprint	New construction consisting of 4860sf, see concept building
Additional site requirements	Not applicable
Projected Cost Analysis	Site Work: \$109,823.00
Building Cost Analysis	Building: \$1,122,313.00
Combined Development Cost	Total: \$1,232,136.00
Potential Fire Suppression	\$60,000
Potential On-Site Electrical	18-20 kW Solar Photovoltaic System \$68,000

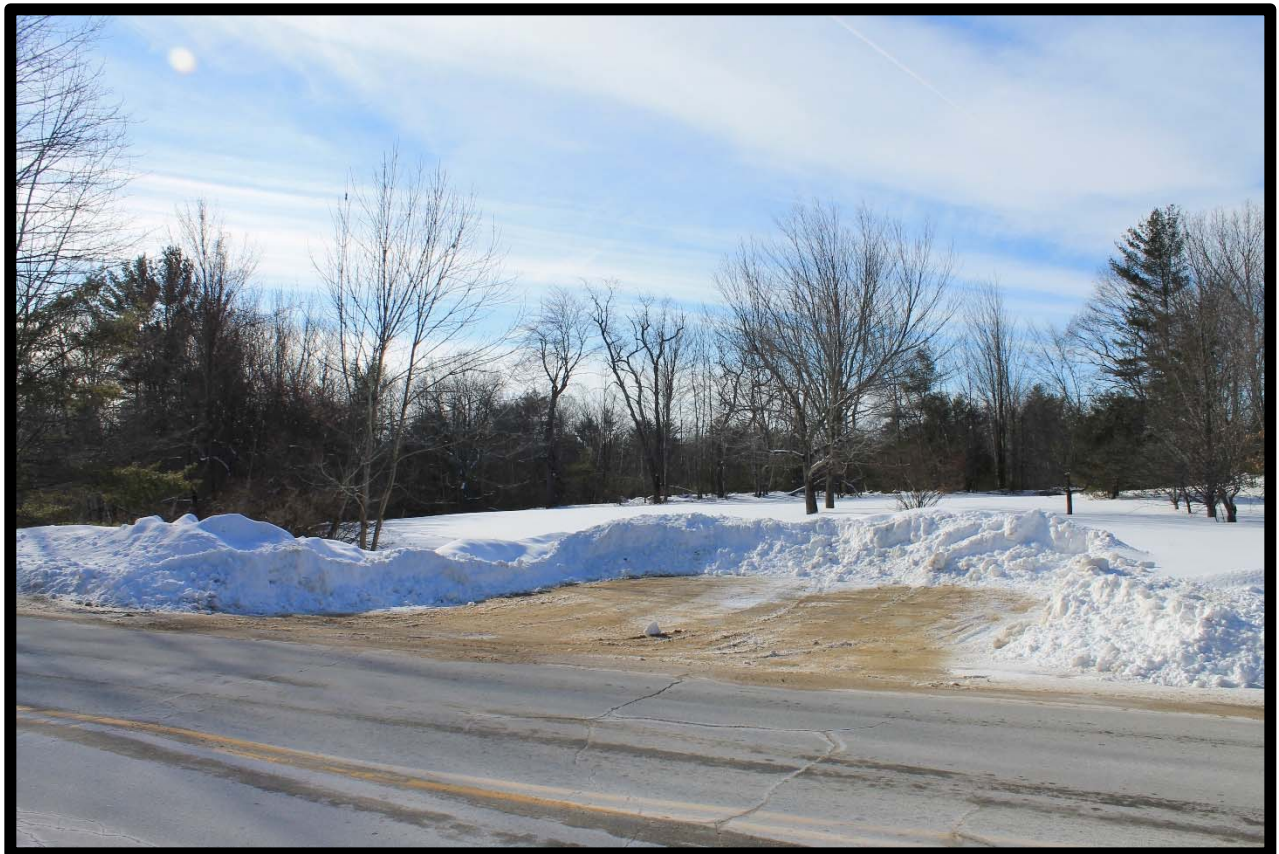
### 3.7 OPTION 2 – DEARBORN SITE

The following is a possible site layout based on the exiting conditions of the 'Dearborn Site', utilizing the same generic building plan indicated on the base plan option.

Approximate Size:	Town owned site, developing 38,800sf of larger property
Topography:	Flat area at street, sloping steeply up to east of site
Existing Infrastructure:	Some infrastructure available, new well and septic required
In Current Use:	Previously developed site, presently cleared.
Proposed Building Footprint	New construction consisting of 4860sf, see concept building
Additional site requirements	Not applicable
Projected Cost Analysis	Site Work: \$116,063.00
Building Cost Analysis	Building: \$1,122,313.00
Combined Development Cost	Total: \$1,238,376.00
Potential Fire Suppression	\$60,000
Potential On-Site Electrical	18-20 kW Solar Photovoltaic System \$68,000

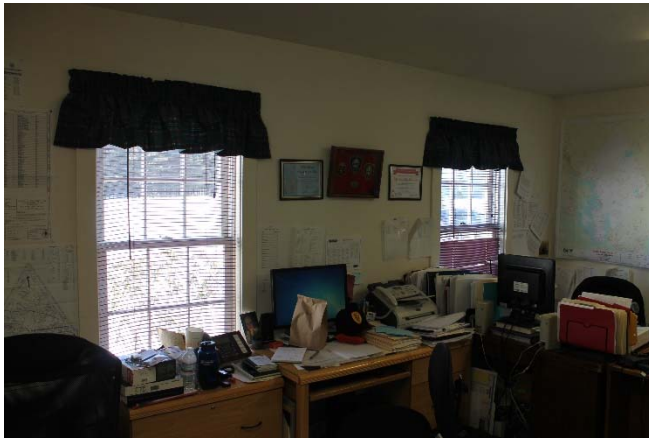
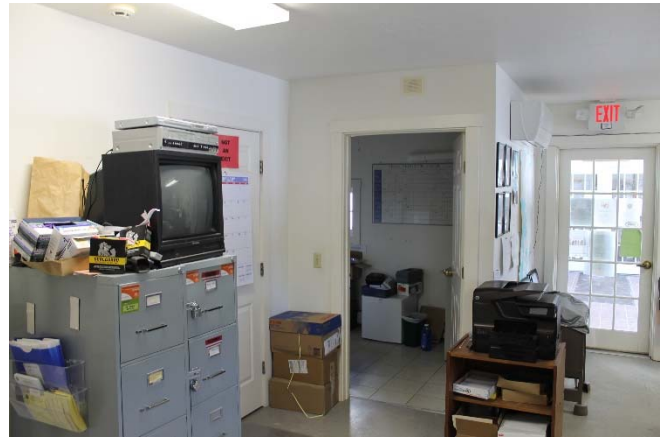
The existing department facility is comprised of a four-room space, including large item storage in garage area and the single toilet room, with limited storage or space required for the daily functioning of the department. The following is a list of deficiencies created by the limited space within the facility:

- Single public entry direct into common/multi-purpose space, unsecured and open to all administrative and policing duties carried out by staff.
- No dedicated/separated administrative area.

MAIN/ALL PURPOSE WORKSPACE/ENTRY

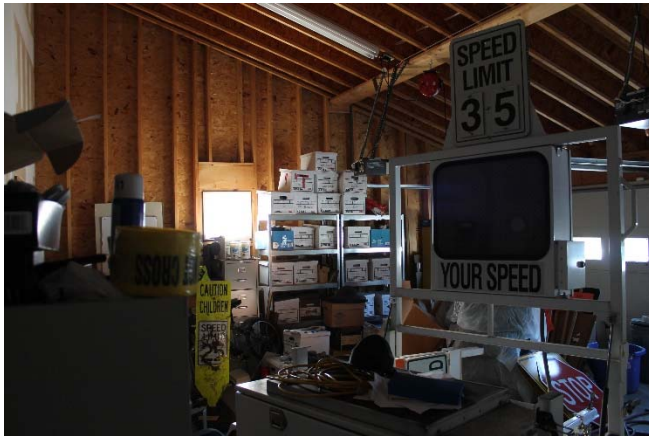
The garage is exposed framing throughout with no insulation or interior finish, except at walls to cape and exit enclosure.

GARAGE/LARGE STORAGE AREA

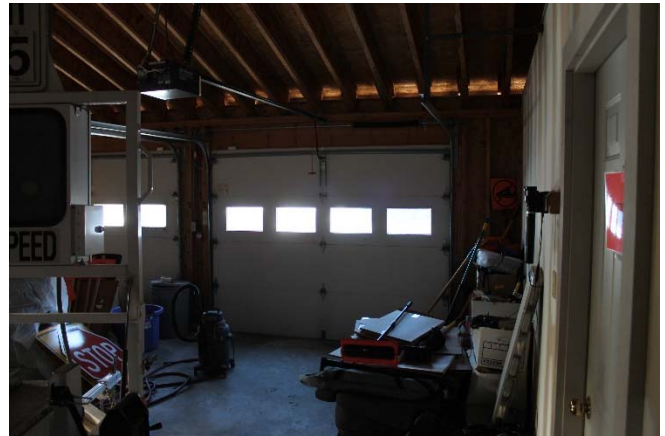
The two 9' wide by 7' high garage doors are 4-leaf sectional overhead doors with a row of 4 glass panes in the third-from-bottom panel.

GARAGE DOORS/FRAMING

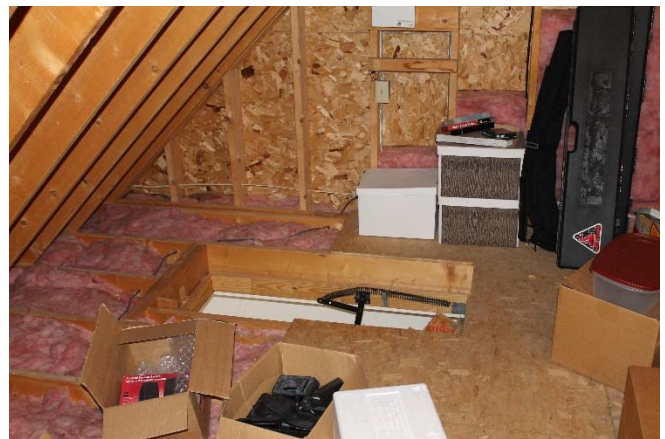
ROOF ACCESS AND STORAGE AREA

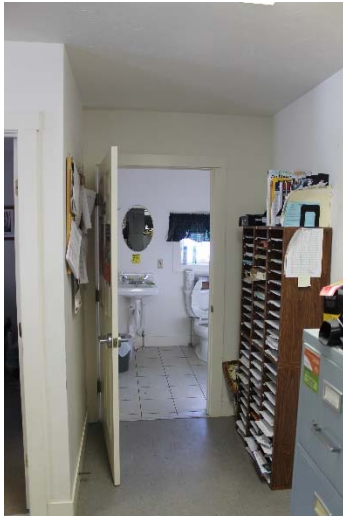
There is one bathroom located off the main space. It is not ADA compliant nor properly ventilated. It contains a water closet and a vanity sink. No drinking fountain or cleaners sink is provided.

W.C./RECORDS AREA

- Life Safety- Provide new exterior lighting at all egress doors. Review alarm system for compliance.
- Electrical- Upgrade as required. Repair/replace existing receptacles that are damaged.
- Plumbing - Upgrade all plumbing fixtures and fittings to comply with ADA requirements.
- Mechanical - Replace existing w.c. extraction fan with new. Provide new heat recovery ventilator in attic space to provide mechanical ventilation to all spaces during heating season.

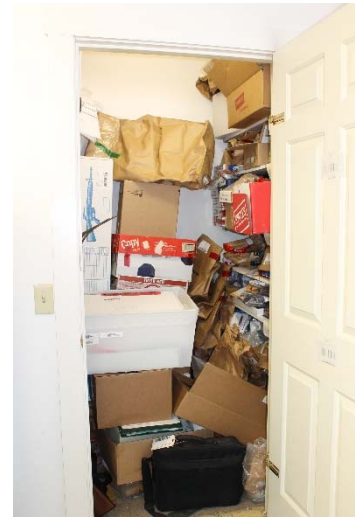
No ventilation is available for the evidence storage either.

- No properly conditioned secure records storage for archived records.
- Limited secure active records storage
- No properly secure, ventilated, evidence storage appropriate for the quantities of evidence presently being dealt with.

EVIDENCE STORAGE

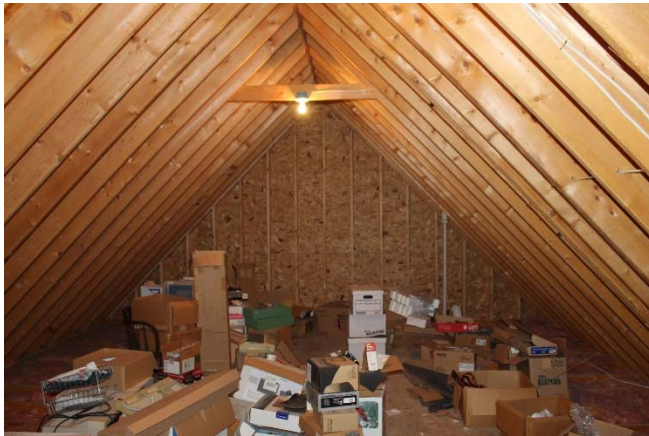
The roof structure is framed with 2x12 rafters at 16" centers with the collar tie forming the ceiling framing. The shed roof is over-framed on the cape roof with 12" plywood web joists at 16" centers. This roof bears on the west wall of the cape and continues to the west wall where the garage doors are located.

The roof framing is also in good condition and shows no real signs of deterioration.

Attic insulation is generally 12" of loose fiberglass batts.

Quality of installation has been compromised in many areas significantly reducing effective performance. No apparent water ingress issues or impending structural failures.

MAIN ROOF FRAMING/STORAGE

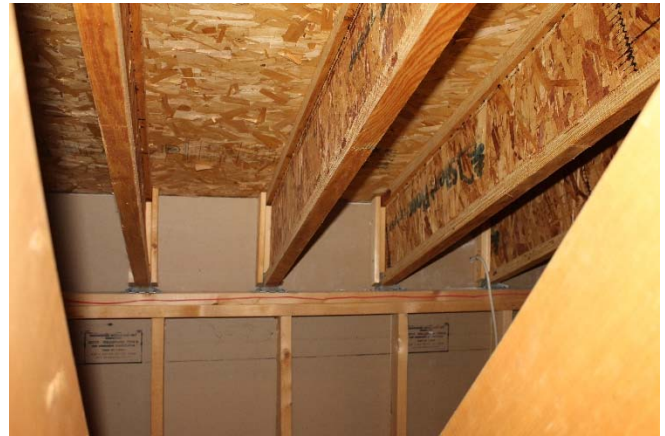
GARAGE SHED ROOF OVERFRAMING

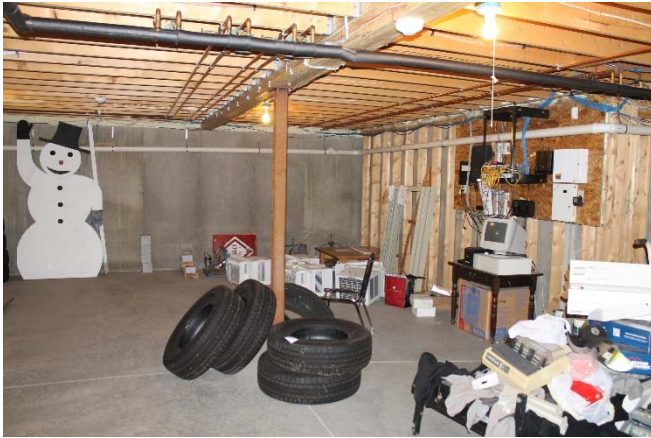
The building is a wood framed structure, with 2x walls, sheetrock interiors and clapboard/shake exterior. The cape portion has a floor structure primarily of 2x12 floor joists at 12" centers, on 8' cast-in-place concrete foundation walls (7' 8" above slab). The foundation walls and floor structure are in good order and require little to no maintenance.

BASEMENT STORAGE & FRAMING

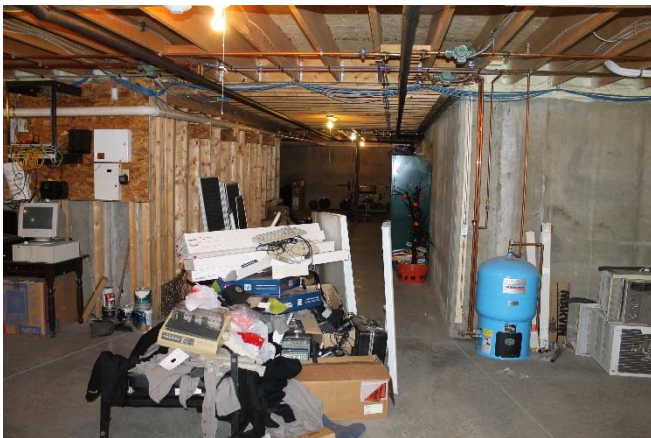
BASEMENT MECHANICAL AREA

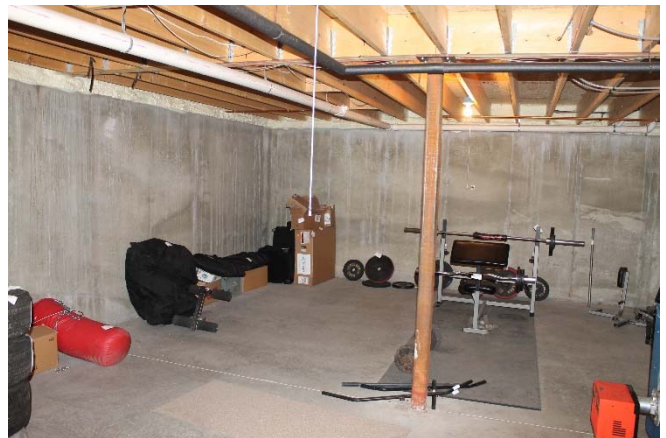
- Inadequate staff facilities in terms of hygiene, personal storage, changing areas.
- Limited fitness area in basement, not properly ventilated or conditioned for any business use

BASEMENT WORK-OUT AREA

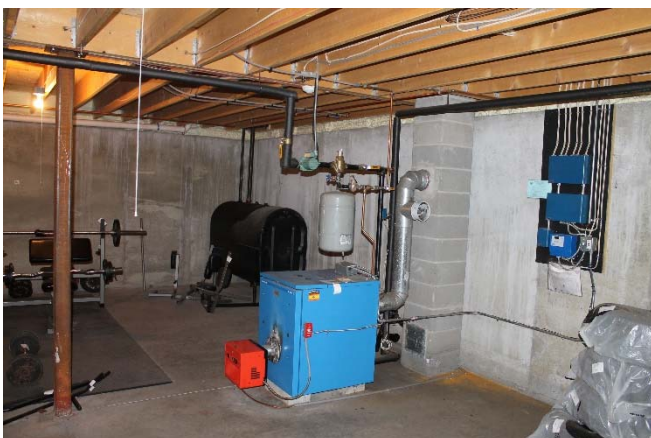
Heating is supplied through a baseboard fin-tube system supplied with forced hot water from the boiler located in the basement.

BASEMENT BOILER AND OIL STORAGE

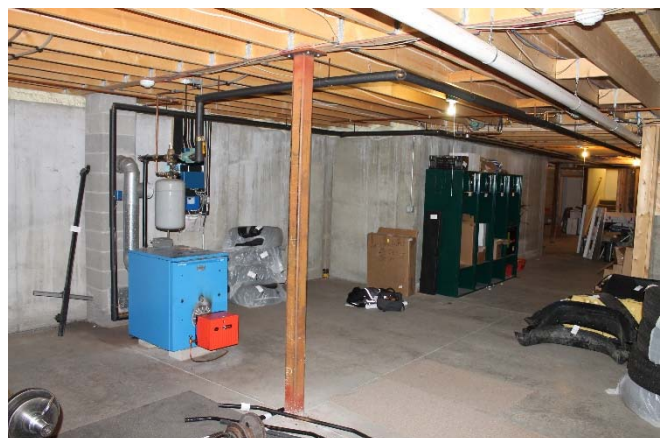
BASEMENT BOILER AND LOCKER AREA
