Tuftonboro Conservation Commission
Town Office Building
304 Middle Road-P.O. Box 98
Center Tuftonboro, New Hampshire 03816

July 31, 2009

Subject: Rapid Wastewater Infiltration Disposal System (RWIDS)

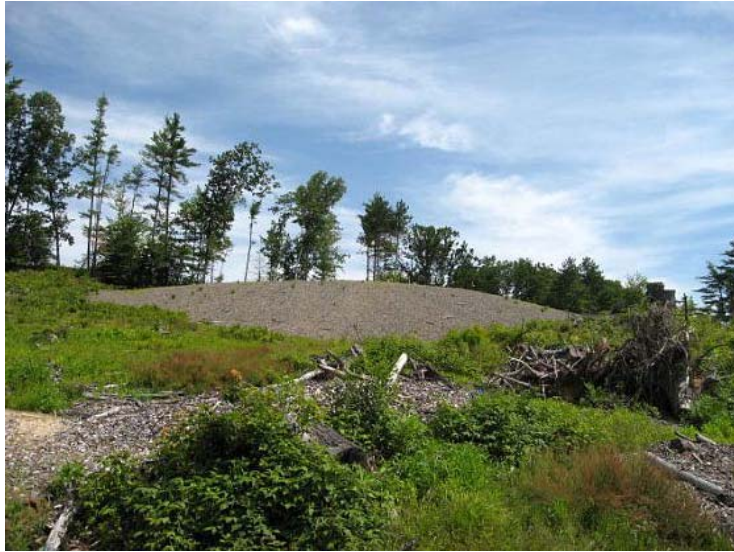
Photo 1. Stabilized burrow pile from RIB excavation

2. On July 18th, 2009 we continued to observe seeps down gradient of the borrow pile (Photos 1 and 2). These seeps were continuing to flow across the topsoil and towards the Brook. At this time the rainfall had subsided for over a week or so. Algae were observed at the base of grasses that were beginning to grow in the stabilization cloth (Photo 3). At the time, we were unable to confirm whether the seeps had infiltrated the wetland soils prior to entering the Brook. However, in another location closer to the access road, a surface drainage channel was flowing out of a wetland area directly below the RWIDS and then directly into the Brook; algae were observed in the Brook at the point of confluence and in areas downstream (Photos 5 and 6).

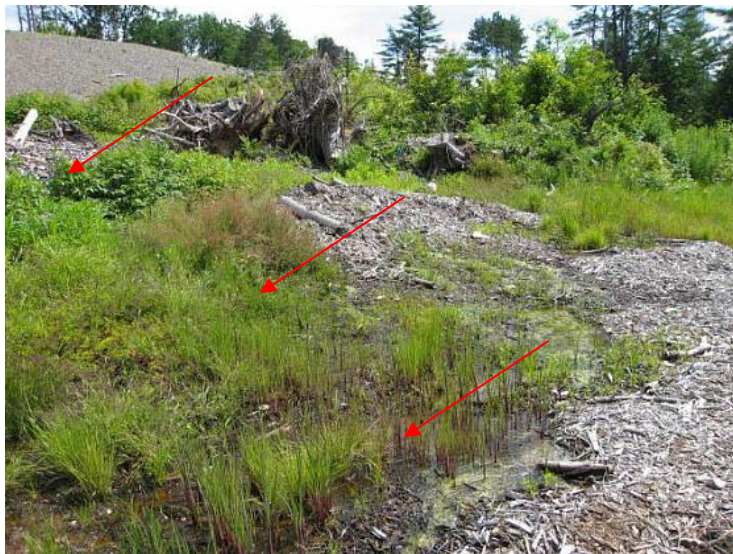
Photo 2. Breakout flow from underneath the burrow pile (foreground of photo)

The location of the seep areas that we observed appears to be consistent with those identified by Watershed Hydrogeologic. Obviously, these seeps may be facilitating untreated groundwater prematurely from the basins, and we are very concerned if they will promote ponding or channeling in the wetlands. Moreover, the untreated groundwater in these seeps is discharging to Nineteen Mile Brook before full *in situ* treatment through the aquifer. We recognize that Wolfeboro is trying to remedy this situation, but we are very concerned that these functional issues are appearing at such early operation of the RWIDS (and presumably at a loading rate well below the maximum of 600,000 gpd).

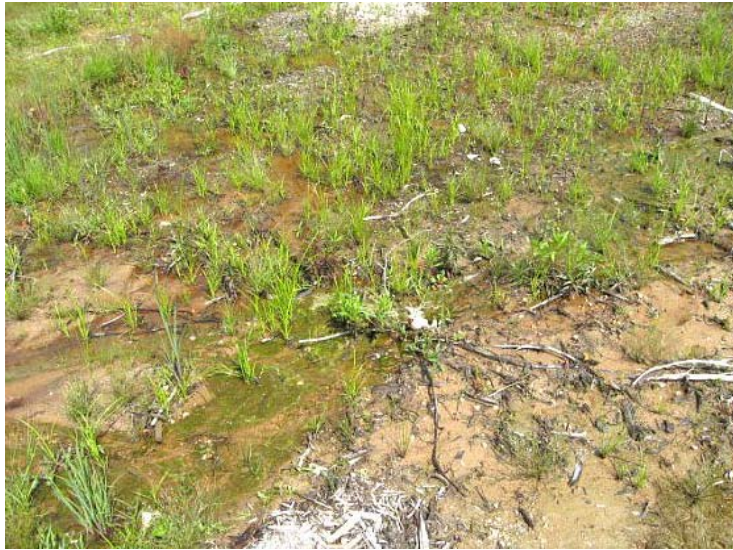
Photo 3. Close-up of breakout flow over topsoil (algae at base of developing grasses)

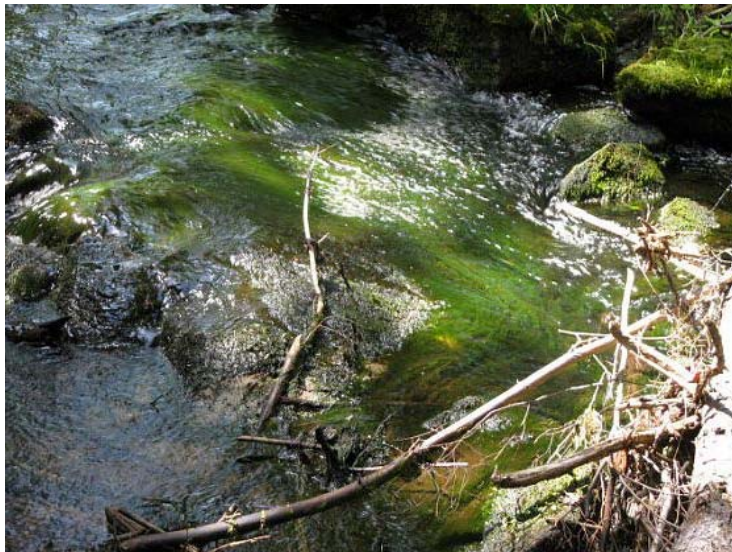
Photo 4. Algae located at the confluence of the runoff ditch from the RIBs to 19 Mile Brook

The algae shown in the attached photos that we observed in the Brook does not appear to be naturally occurring, was not observed in other reaches, and may be directly related to elevated nutrients from the surface drainage channel. Surface water sampling and analysis of this channel (which we believe Wolfeboro is conducting) can confirm this, but the visual evidence even without such analytical data appears to support our concern that the growth of algae in Nineteen Mile Brook is a result of the runoff in this channel. (As an aside, as far as we can tell this surface drainage channel is not specifically identified in the text or figures of the SWDFS and we are lead to believe that this has been overlooked in the design.)

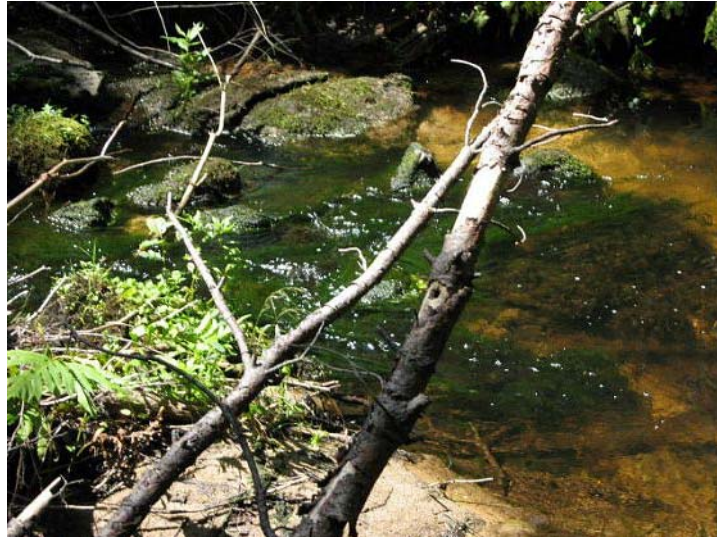
Photo 5. Algae located downstream of the confluence of the runoff ditch from the RIBs to 19 Mile Brook
